MANGANESE STAINING: PREVENTION AND CONTROL

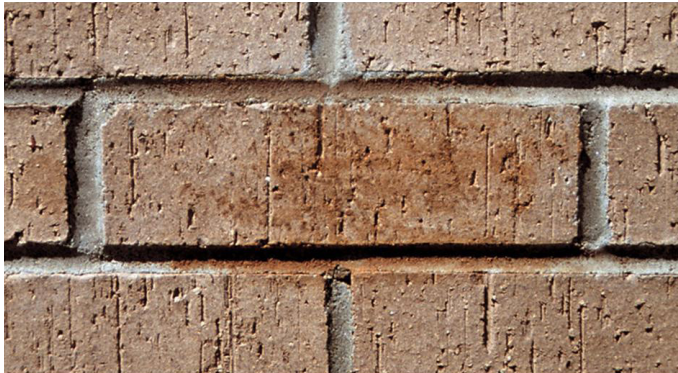
Photo 1: Manganese Stain on Brick

Manganese stain is a brown or tan-colored deposit that remains on the surface of clay masonry after being dissolved by an acid and transported through the brick pores. Such deposits appear on the face of the brick (as shown in Photo 1) or in the mortar joints (as shown in Photo 2). Manganese stains on brick masonry primarily occur when an unbuffered acid such as hydrochloric (muriatic) acid is used to clean the brick, an incorrect cleaning agent is applied, or the cleaning manufacturer's instructions are not followed. These stains can be prevented by adhering to proper brick cleaning methods and are usually removed through the use of a proprietary cleaning product.

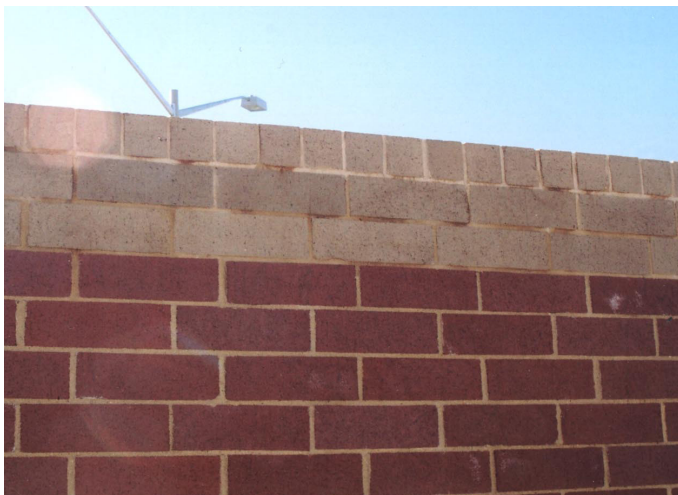
Photo 2: Manganese Stain in Mortar Joints

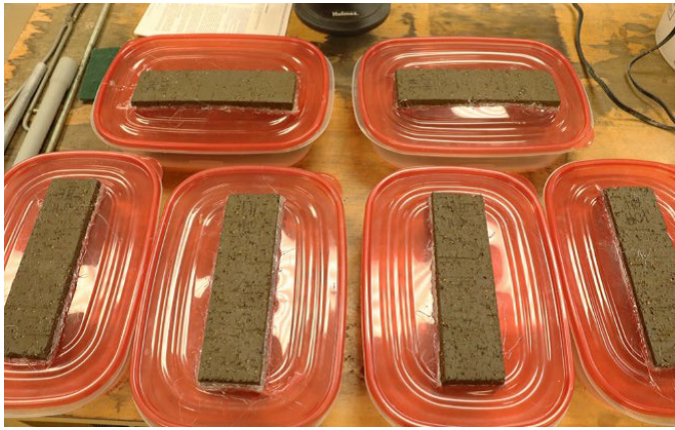
Photo 3: Brick Units Partially Submerged in Water (top left) and Hydrochloric Acid (top right)

In a recent study conducted at the National Brick Research Center (NBRC), brick were partially submerged in either distilled water or unbuffered hydrochloric (muriatic) acid (Photo 3). After exposure, the amount of soluble material in solution was determined for each brick unit (Figure 1), and their appearance was observed (Photo 4). For the brick exposed to distilled water, minor efflorescence was observed, as shown on the right in Photo 4. None of the manganese in the brick dissolved when exposed to distilled water, and no manganese staining was observed. However, brick that were exposed to unbuffered hydrochloric (muriatic) acid dissolved the manganese and iron and took it into solution. The manganese and iron then migrated to the surface and left a dark-colored stain, as shown on the left in Photo 4. While it was found that the solubility of the different unfired manganese compounds varied, the study concluded that for certain types of fired brick, exposure to hydrochloric (muriatic) acid, not water, consistently dissolves manganese and iron. As a result, removing or reducing the acid solvent can be an effective method to reduce or prevent stains in brickwork.

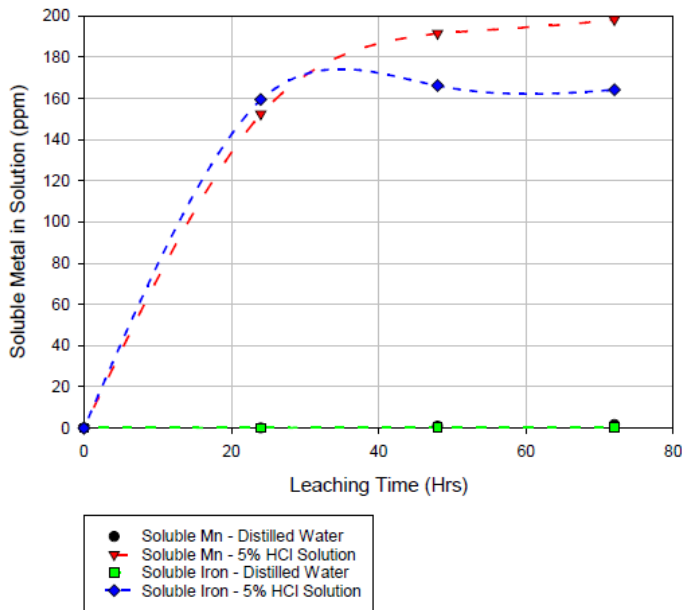
Figure 1: Amount of Soluble Manganese and Iron in Solution

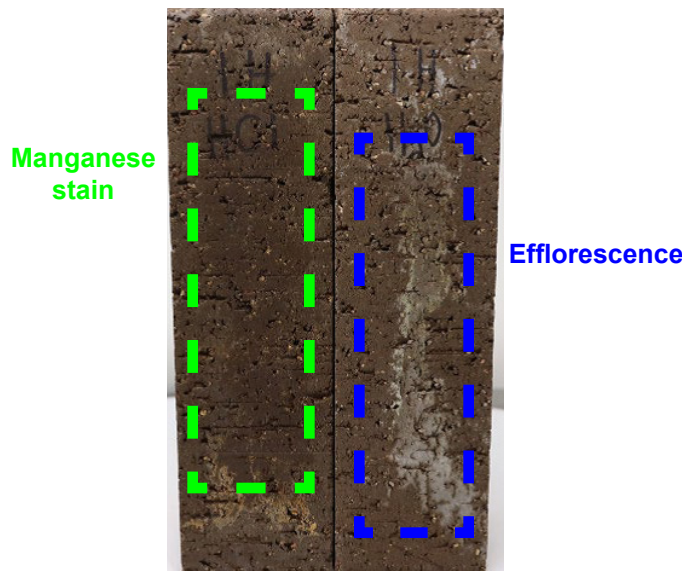
Photo 4: Manganese Stain vs. Efflorescence

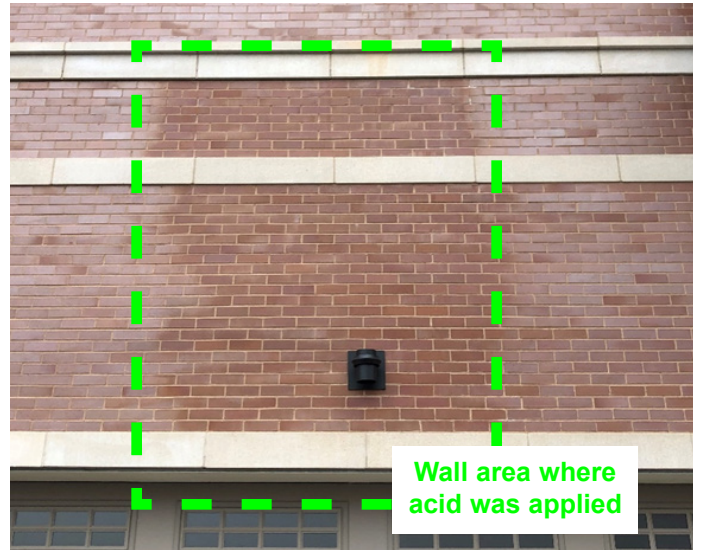
Photo 5: Acid Etched Brick and Removal of Sheen

Staining is not the only consequence of exposure to unbuffered acids. The resulting leaching of manganese and iron can also erode or etch the surface of the brick and alter or remove any finishes or sheen, causing

permanent damage to the brick or the mortar joints (Photo 5).

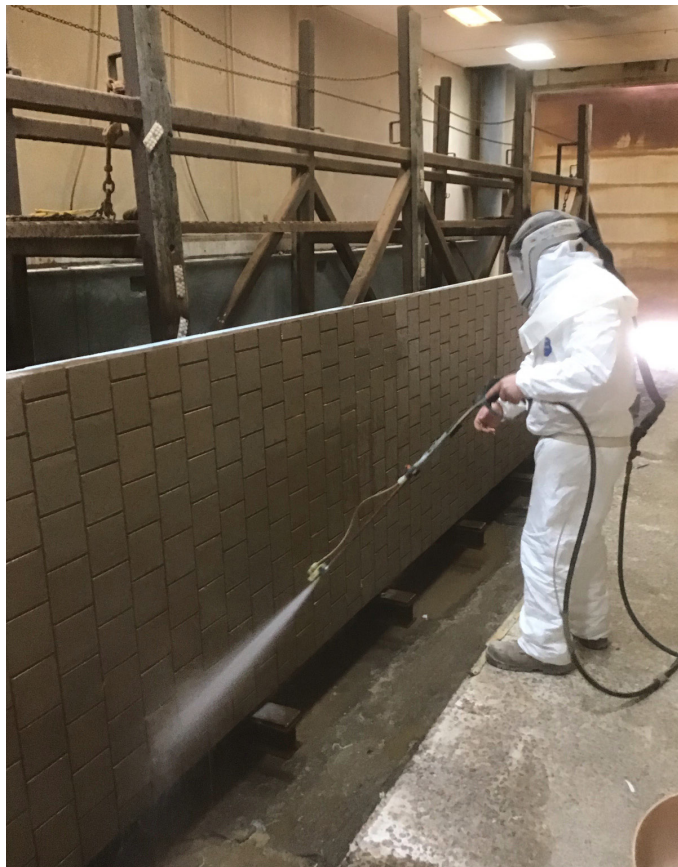
Photo 6: Applying Acid to Brick Embedded in a Precast Concrete Panel

Architectural Precast Concrete Fabrication. Brick embedded in precast concrete panels could be exposed to unbuffered acids as part of the precast concrete fabrication process, as shown in Photo 6. Precast concrete panel manufacturers will often use an unbuffered acid or diluted acid solution on a concrete panel to clean form liner leakage on embedded brick, to create a consistent look for the joints, or to create a “sugar cube” or “sparkle” finish surface effect.
